# THE BRISTOL 70cms REPEATER GROUP

## GB3BS NEWSLETTER 2013

## **Technical Report**

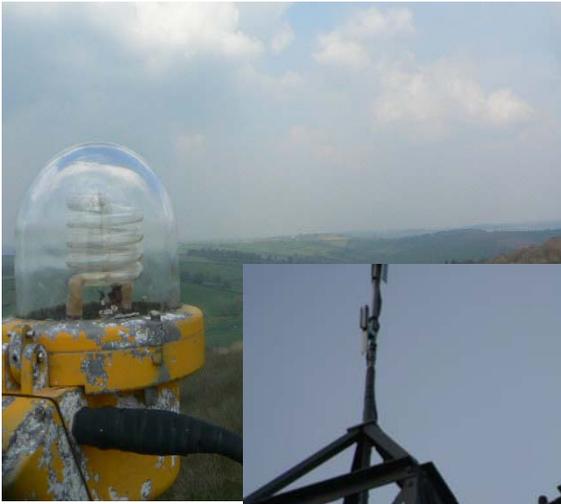
Members may remember that we reported on the problems we were having with the Tower Warning Light and ultimately, its total failure back in July last year. It appears that the old light housing succumbed to water ingress and with it corroded the circuitry.

**Above: The old Neon Lamp.  
Picture taken in 2010.**

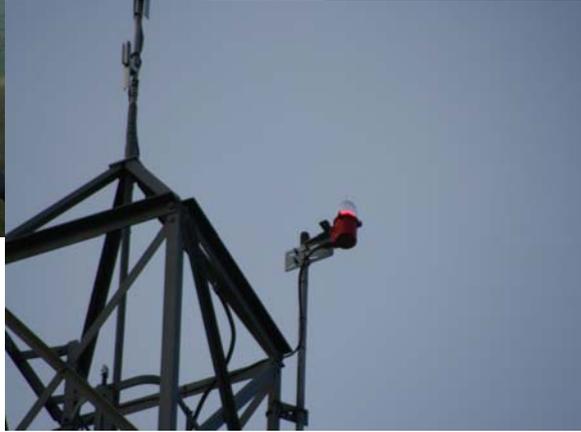
**Left: New LED type lamp fitted January 2013.**

I can now report that back in January this year a brand new LED type Tower Warning Light was installed on the tower and is working well. Hopefully being a LED type it should last a good few years.

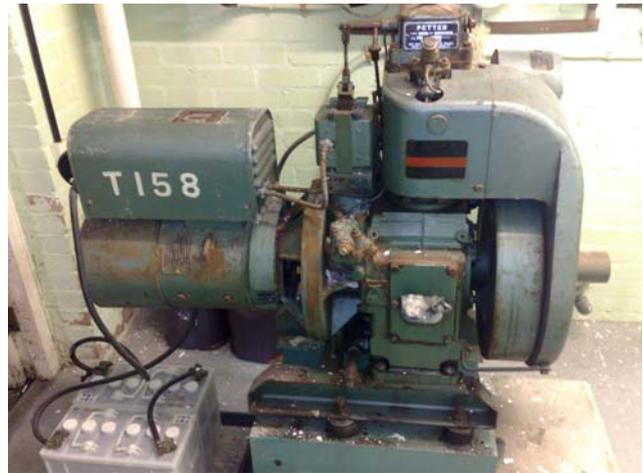
The site generator has been given a quick check over and the starter batteries with its float charger were also checked. The generator is usually given a run and a load test once a month for about an hour. We simulate a full mains supply failure so that we are sure that there are no problems with the auto start system. We must get round to trying a manual start one day!

**The 3kW Standby Generator.**

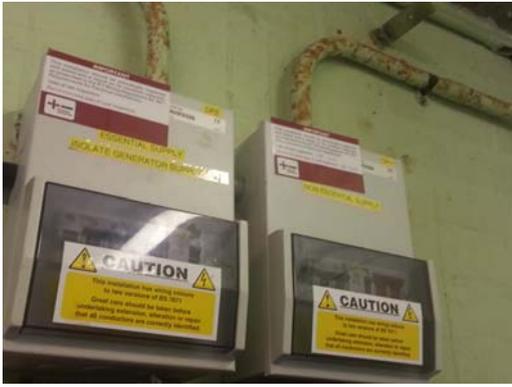
The newly certificated fuse boards.

Late this year we had a site electrical safety inspection. This is the first one we have had since occupying the site. We are not sure what instigated this or how often it will be repeated, perhaps it's because the site was rewired and upgraded by us that they actually felt safe to inspect it now! Anyway, the site was given the all clear and has been certificated, which is reassuring that the work and materials the group invested in meets the current regulations. (Did you have doubts? – ED)

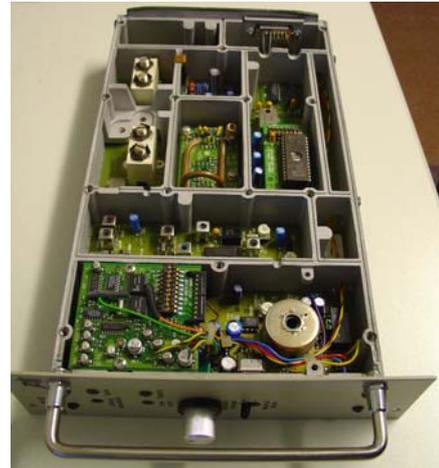
**[Receiver]** At the start of July our main receiver (RX1) was returned to service. RX1 was originally removed so that we could check that some of the manufactures recommended performance modifications had been installed. Fortunately they had, so following a quick performance and level check over it is now back where it should be.

RX1 having a check over.

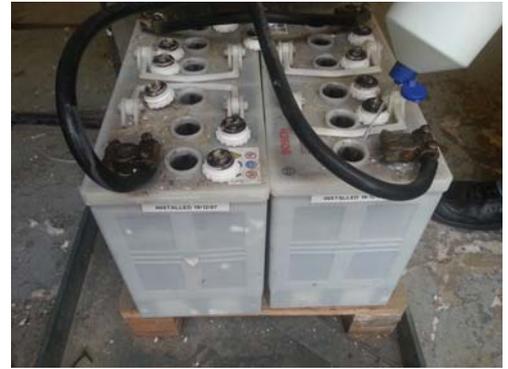
While up on site today carrying out the “Pip” modifications (See Above) we carried out a Generator load test, this failed! The generator would only turn over very slowly. Quick Voltage test showed the batteries were at fault.

On inspection we discovered the batteries were dry. How this has missed inspection previously we are not sure.

A dash to the local fuel station resulted in a single 1ltr bottle of de-ionised water, a VERY expensive bottle at that. I (Mat) then shot up to the garage near Marshfield and subsequently cleared them out of 1ltr bottles, all 5 of them. The young lady did look surprised as the bottles did look like they had been there for a while. Anyway, returning to site all 12 cells were topped up, left on the boost charger position on our charger for around 10 minutes until bubbles were seen in the cells. We then re-tested the generator start, and this worked fine. The test procedures have now been modified to ensure levels are tested more regularly.

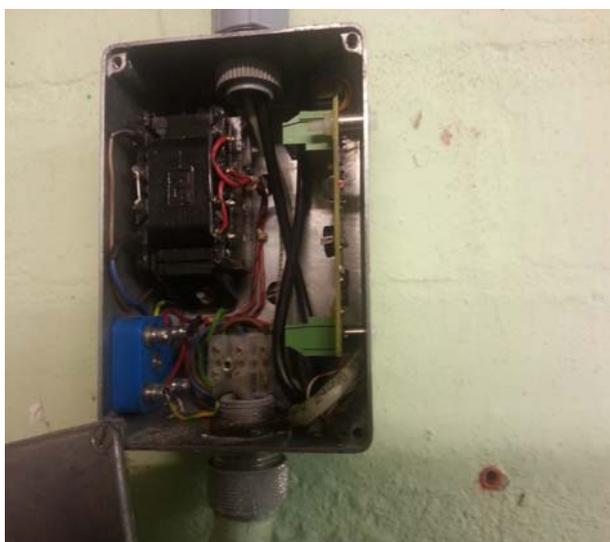
During this work we found a slight signalling problem with the “Generator Running” alarm.

We did not have time to fully investigate, but potentially it is a capacitor fail on the DC supply circuit. This is making the signal “Bounce” when triggering the alarm. The result at the moment is a “Power Failure Alert Clear” being sent instead of the correct “Alert Active”. Work will continue over the next week or so, this does not affect the repeater operation.
