THE BRISTOL 70cms REPEATER GROUP

GB3BS NEWSLETTER 2013

RU68 - 430.850MHz - TONE J: 118.8Hz

Technical Report

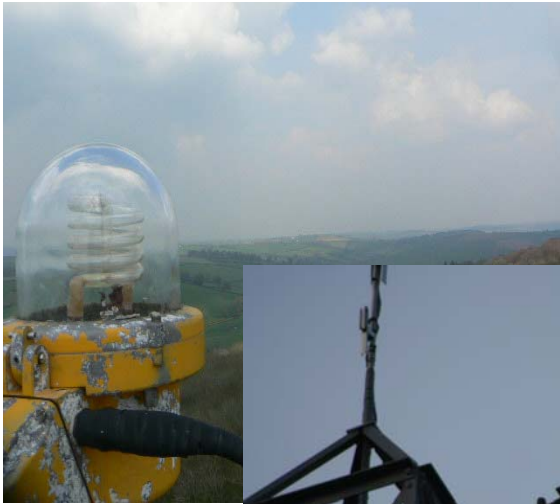
Members may remember that we reported on the problems we were having with the Tower Warning Light and ultimately, its total failure back in July last year. It appears that the old light housing succumbed to water ingress and with it corroded the circuitry.

**Above: The old Neon Lamp.
Picture taken in 2010.**

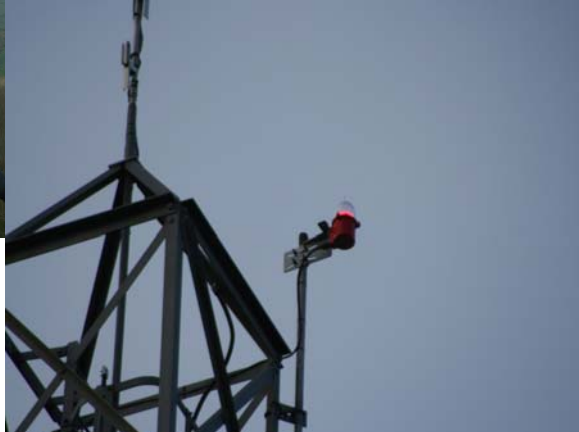
I can now report that back in January this year a brand new LED type Tower Warning Light was installed on the tower and is working well. Hopefully being a LED type it should last a good few years.

Left: New LED type lamp fitted January 2013.

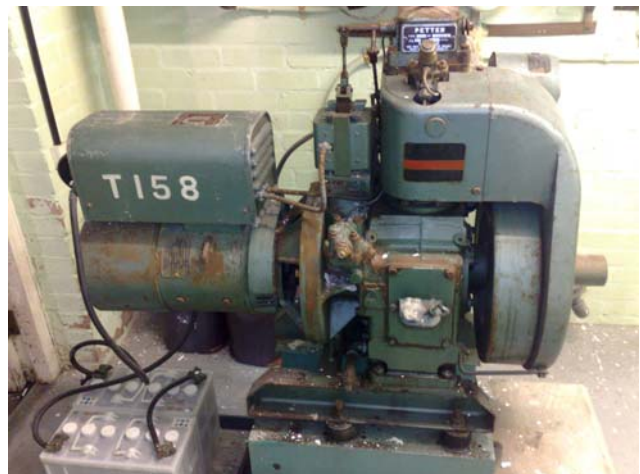
The site generator has been given a quick check over and the starter batteries with its float charger were also checked. The generator is usually given a run and a load test once a month for about an hour. We simulate a full mains supply failure so that we are sure that there are no problems with the auto start system. We must get round to trying a manual start one day!

The 3kW Standby Generator.

While up on site today carrying out the “Pip” modifications (See Above) we carried out a Generator load test, this failed! The generator would only turn over very slowly. Quick Voltage test showed the batteries were at fault.

On inspection we discovered the batteries were dry. How this has missed inspection previously we are not sure.

A dash to the local fuel station resulted in a single 1ltr bottle of de-ionised water, a VERY expensive bottle at that. I (Mat) then shot up to the garage near Marshfield and subsequently cleared them out of 1ltr bottles, all 5 of them. The young lady did look surprised as the bottles did look like they had been there for a while. Anyway, returning to site all 12 cells were topped up, left on the boost charger position on our charger for around 10 minutes until bubbles were seen in the cells. We then re-tested the generator start, and this worked fine. The test procedures have now been modified to ensure levels are tested more regularly.

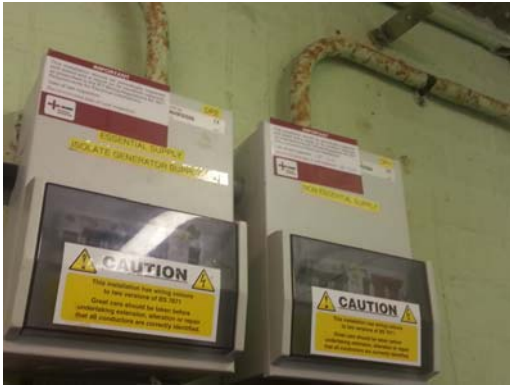
The newly certificated fuse boards.

Late this year we had a site electrical safety inspection. This is the first one we have had since occupying the site. We are not sure what instigated this or how often it will be repeated, perhaps it's because the site was rewired and upgraded by us that they actually felt safe to inspect it now! Anyway, the site was given the all clear and has been certificated, which is reassuring that the work and materials the group invested in meets the current regulations. (Did you have doubts? – ED)

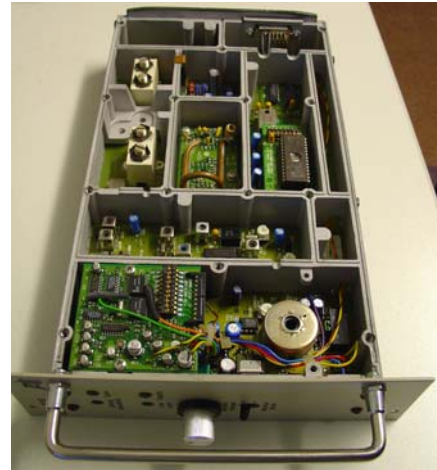
[Receiver] At the start of July our main receiver (RX1) was returned to service. RX1 was originally removed so that we could check that some of the manufactures recommended performance modifications had been installed. Fortunately they had, so following a quick performance and level check over it is now back where it should be.

RX1 having a check over.

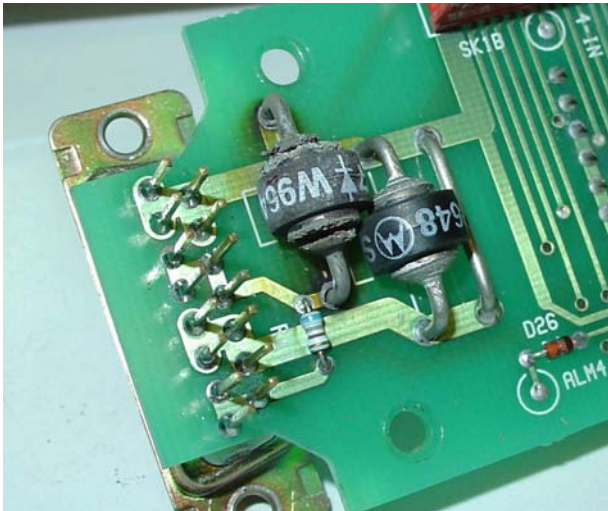
Back in mid August we attended site after the repeater unexpectedly went off-air. At site we found that the main 12v DC PSU was in Standby mode and the backup battery was flat! The PSU was power cycled and it immediately came back on-line and the repeater rebooted itself. The standby battery also began recharging. No faults were found as to what caused the PSU to go into standby.

Actual alarm board with the failed diode.

No faults were found with either the PSU or Battery. After some serious head scratching I decided that the only common unit left was the Alarm & DC Power Distribution unit. This is a plug in unit that displays any alarms that are present and is also used to distribute the DC power to the rest of the repeater system.

As soon as the cover was removed the cause of our power problem was revealed. The main power diode located on a small PCB had started to detach itself from its leads and the PCB through holes. Giving the PCB a sharp tap the main body of the diode dropped away leaving the leads still connected to the PCB. Clearly this diode had, over much time, been getting warm and then cooling causing the diodes body to become fractured and making an intermittent circuit.

Studying this set up seemed to suggest this is a bit of a design flaw and could potentially happen again if it was simply repaired. As this power diode is crucial to the DC supply I decided to mount a new style of diode and a better rated one on the metal chassis and run some short heavy duty wire between it and the PCB. This results in any heat generated by the diode is now safely dissipated away on the metal chassis rather than just the leads of the diode itself.

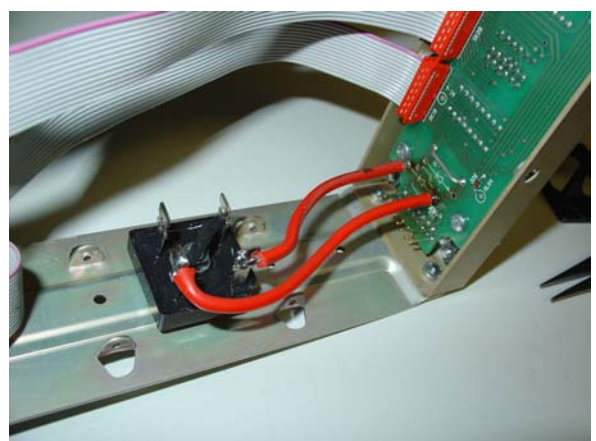
Alarm board fitted with new diode block.

The now modified unit was returned to site and re-installed without any problems. The now spare unit was inspected and although not as bad as the main unit, it did show similar signs of diode heating problems on the PCB. This spare unit was similarly modified and so this power problem was finally solved and should not happen again.

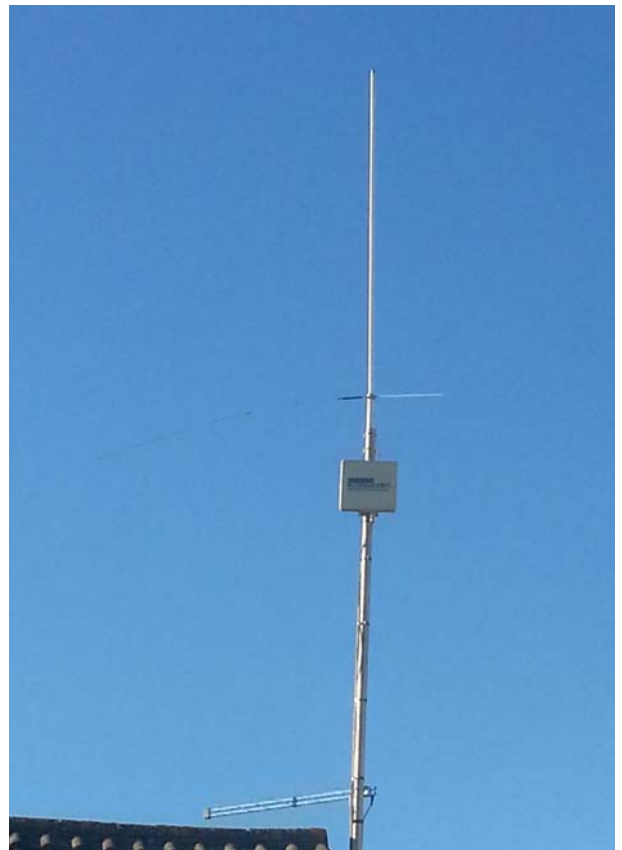
Last year we mentioned our intention to get a 10 M/bit Ethernet link running between the repeater site and Mat – G7FBD’s home QTH. This will allow us to better monitor the sites environment and control the repeater.

The good news is that the equipment and Panel Antenna array has been installed at Mat’s QTH and is warmed up ready to go. We are currently waiting for some good weather so that we can initially survey the repeater site as to the best location for the Panel Antenna to be positioned. We are hoping that this may only need a short pole secured to the building to get the link established.

The 2.4GHz “A” end of the WiFi link.

If this does not work then we will be looking at mounting the Antenna a short way up the tower so as to clear any ground obstructions and secure a reliable link. Current path predictions show that the link should give us around 98-99% availability. Once installed we will run some long term Bit Error Rate tests to see how good and reliable the link is.
