THE BRISTOL 70cms REPEATER GROUP

GB3BS & GB7BS

NEWSLETTER 2014

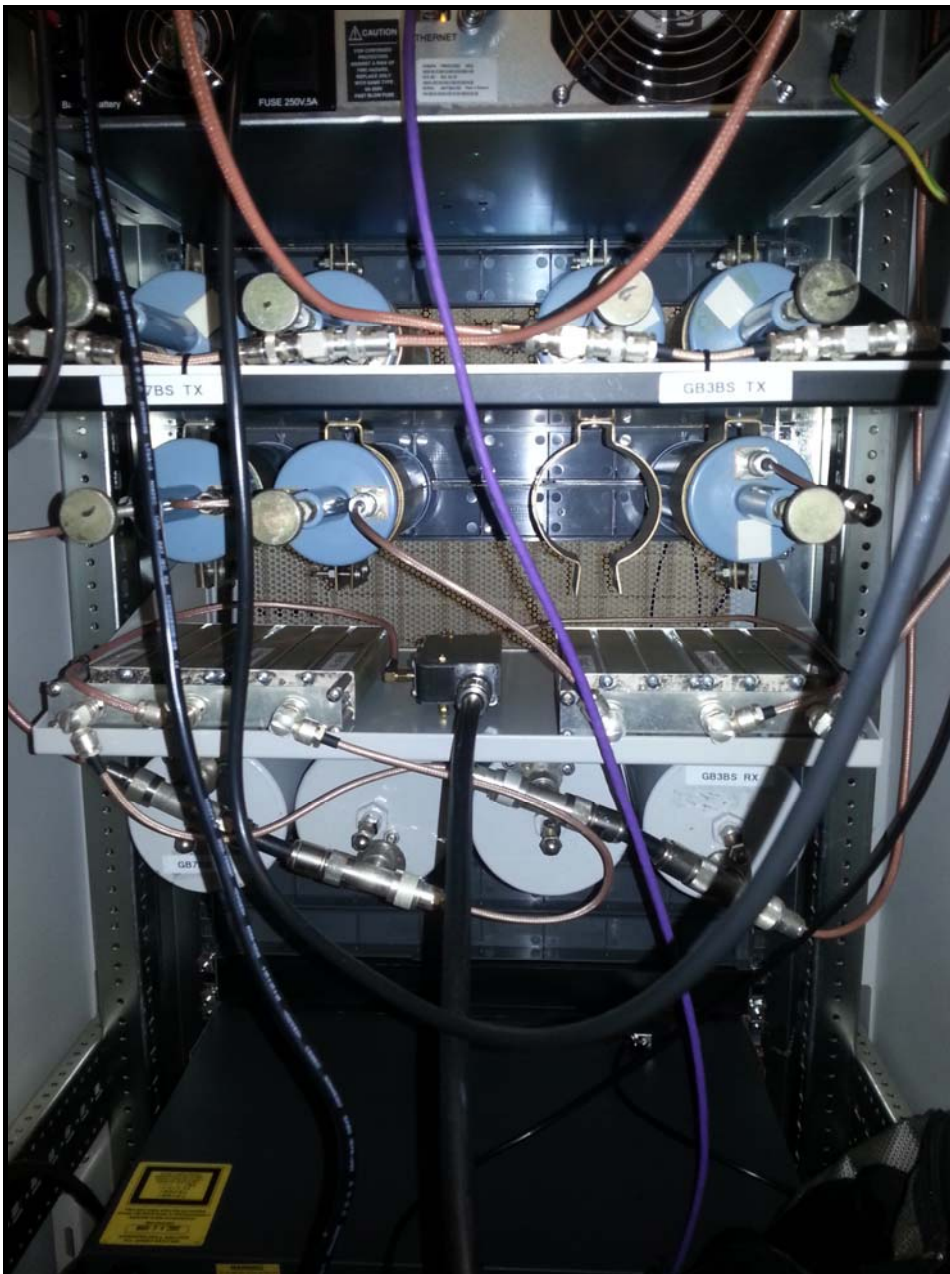
The Picture (Left) is a more detailed picture of the Filter and diplexer trays Built by Mark G4SDR.

At the top of the picture You can see the bottom rear of the DR3000 Mototrbo repeater.

The three filters below this are the band pass filters for GB7BS TX, the missing filter, and the filter on the right (not connected) are the proposed band pass filters for GB3BS TX (if needed).

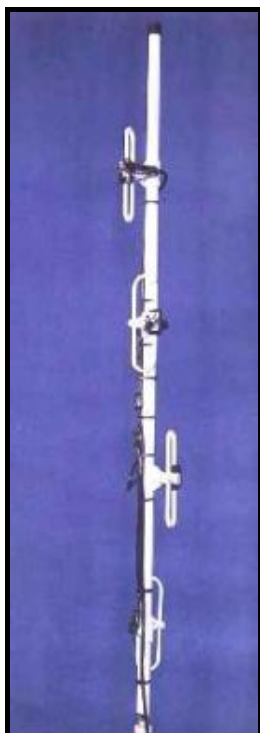
The picture on the left is the type of antenna we are now using. It is the "Radio Structures UHF 4 stack". It has almost the same if not a better RF specifications as the old SA460 at 5.5dbd.

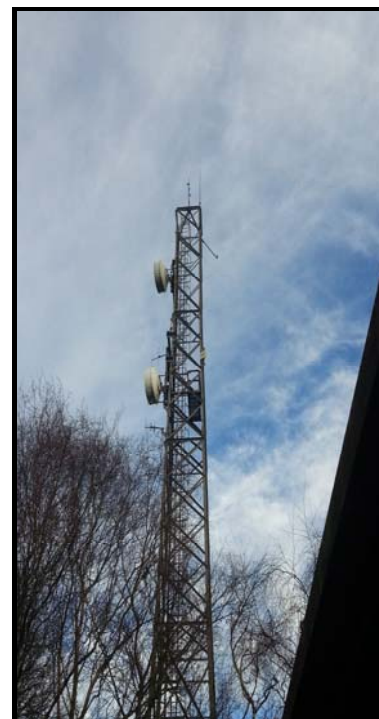
The picture on the right shows the new antenna right at the top of the tower (30m AGL).

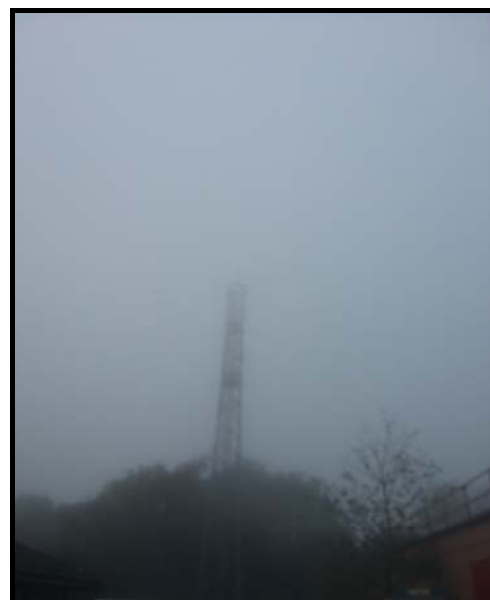
We assembled the antenna mounting brackets, which had to be type rated for tower use. Then we mounted the dish (Panel) to the bracket, so far ever thing was going good. Connection of the feeder cable complete, Mark started work on bandaging the connection with Denso tape. Once totally embalmed we went back outside to take a look at the tower, it had turned into a nice sunny day. The Fog had almost totally burned off.

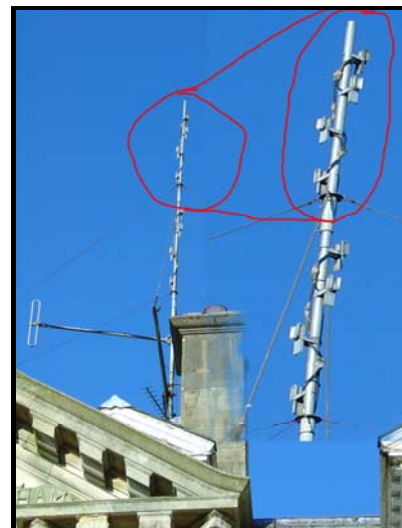
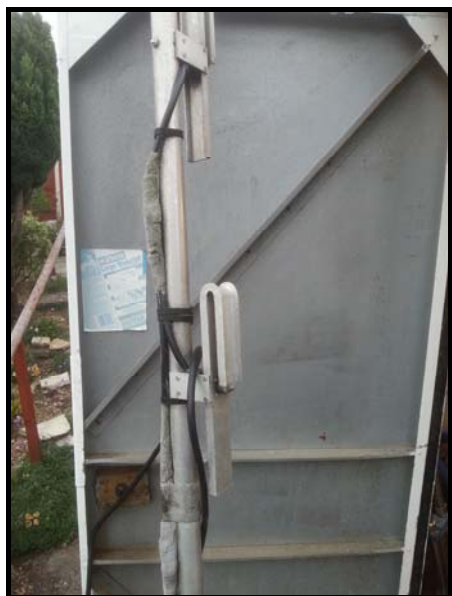
Initial visual inspection for any damaged to the main feeder showed no possible cause of the SWR problem. So I removed the faulty antenna back to Mat Manor (QTH) to have a closer inspection

Firstly, before any work was undertaken, all radiating elements were labelled so their location could be identified once things had been disassembled.

Once labelled up, I started off by looking at the obvious parts first. The Feeder and N-Type connector, I was looking for signs of jacket fracture, water ingress or possible impact damage to the coax. Nothing was found, Denso had lived Up to its name!

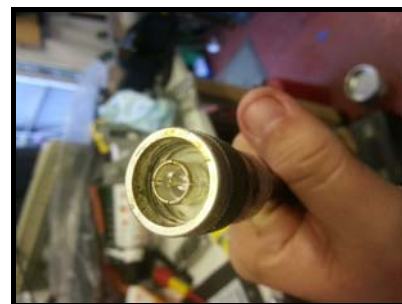
The outer sheath of the feeder was cut back to approximately 30mm from the plug, checking for water discolouration and, what in the electrical world is sometimes referred to as Cable Cancer. Again, nothing was found other than clean, bright copper. No sign of water in the coax at the plug end, this re-enforced the fact that the joint was water proof.

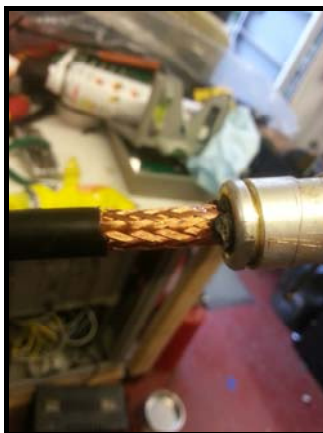
The stripped down plug was also fine inside. No water marks!

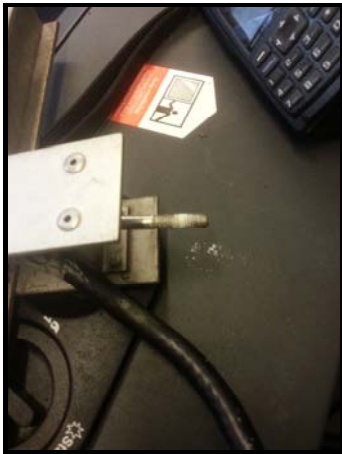
It was noted that the feed point formed a basic capacitor, between it, and the element. Stripping one of these points down confirmed this theory as construction was nothing more than an insulated stud connected to the inner of the coax, which then was electrically insulated from the folded element by insulated washers.

Elements one, two and four (counting from the bottom), all looked fine apart from a little surface corrosion to the element itself, and to the stud, but nothing to worry about.

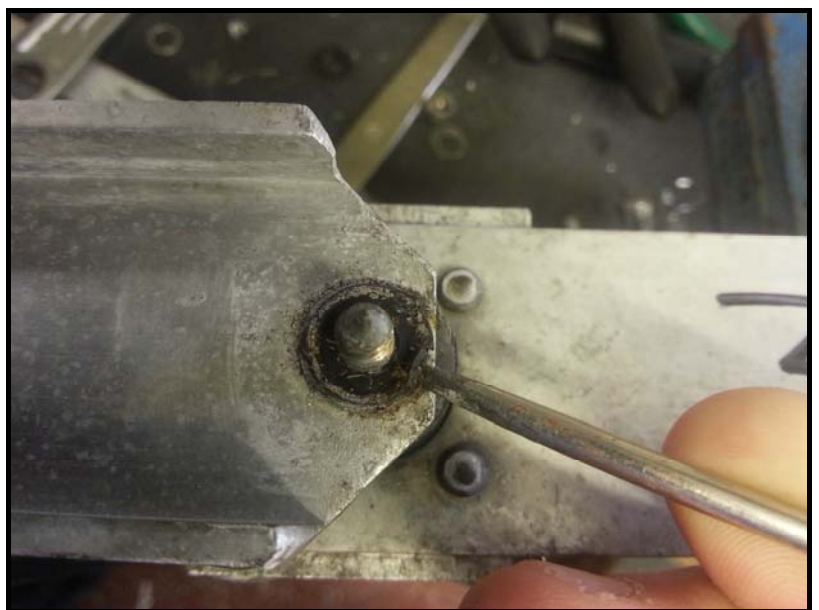
Gentle heating (Heat guns have many uses including shrink sleeve!) to a temperature that was uncomfortable to touch the over all DC resistance was reduced from $>100\text{M}\Omega$ to $<2\text{M}\Omega$

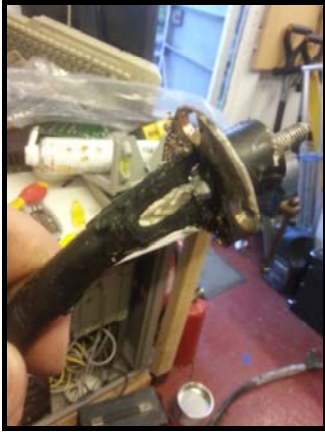
After stripping this feed point down and removing this insulator, it was discovered it was in fact a steel washer with a rubber coating, and the coating was crumbling around the washer.

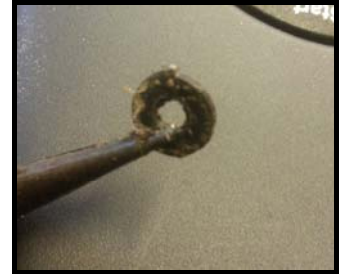
It was then theorised, using the tests done above, and observations made while the antenna was on site, that as the antenna warmed in the summer sun, its capacitance reduced to such a point that at UHF the feed point appeared as a low impedance on element 3. This was causing a high(er) SWR to be presented to the PA of the Transmitter, which in turn had its own SWR Bridge which caused the PA

to back off the power and therefore was also causing a loss of received signal to the end user.

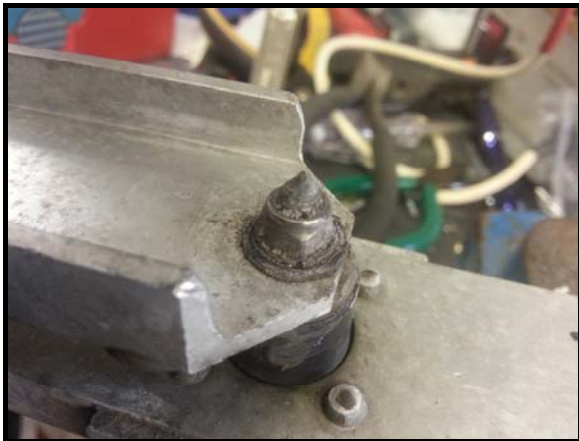
However element 3 it was noted that the rubberised insulation washer insulating the stud from the element, forming the capacitor, was fractured in several places.

The picture left shows element No. 3 before I stripped it down. You can see the crumbly washer resting on the radiating element. Just below the locking nut and the plain "A" washer.

The gunge shown on the black nylon block below the element is factory applied silicon rubber.

A fault that to be honest, the repeater group would not of had 100% confidence in if we attempted a repair, and that with the aforementioned cost of a pair of riggers, changing the antenna was really the only sensible solution.

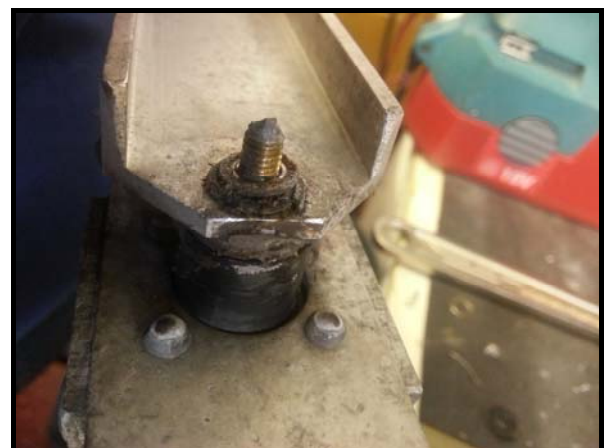
Above, is element No.3 with the locking nut removed, look carefully on the right side of the washer, you can see its insulator coating has broken up badly.

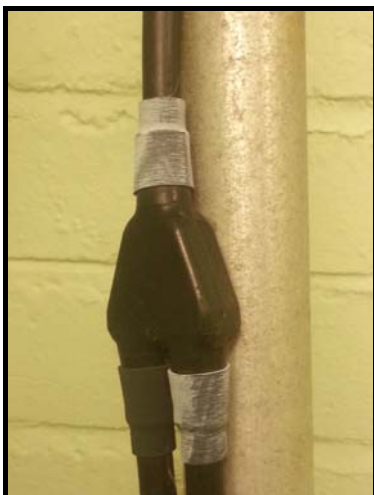
One of the coax dividers forming part of the phasing harness.

The two white marked coaxes each go off to each of two elements. This is duplicated below for the other element pair. The black tails go off to a power divider then on to the incoming feeder.
