# THE BRISTOL 70cms REPEATER GROUP

**GB3BS and GB7BS**

## NEWSLETTER 2021

## Technical Reports by Mark - G4SDR

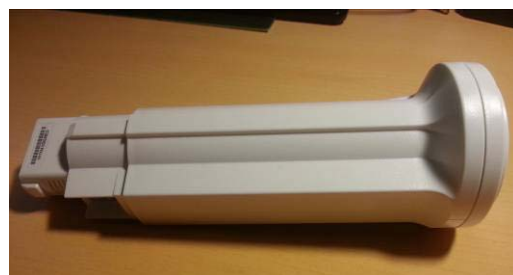
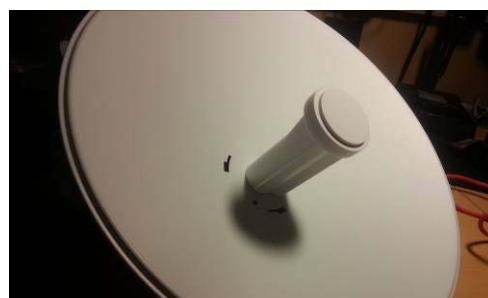
The main Microwave link between Mat’s QTH and the Repeater site was also checked, although there is virtually nothing to do as the transceivers are non serviceable units. About the only thing to do is update its firmware when required and check that Ethernet connections are secure and waterproof.

After a few configuration changes to the Microwave link equipment we are now managing to get reliable error free throughputs of around 55 Mbps on both uplink and downlink. Which is vastly more than we need, and currently faster than I get at the home QTH, much to my annoyance.

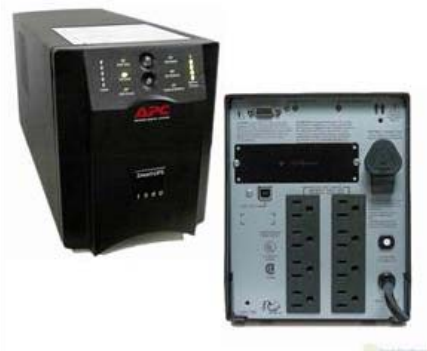
One problem that crept up on us was that the main UPS that keeps 240v AC supplies to the Microwave Link (which supports the SWC Network), Cisco Switch, MB7VV APRS, Blitzortung Lightning Receiver and the main Server developed a Battery problem. A quick check found that the two sealed lead acid batteries had come to end of life and needed replacing.

It was a good job we did a spot Generator and UPS test or we may not have known about it until the next site mains fail. Goes to show that a bit of site maintenance

A quick dash to the local battery shop secured a pair of new batteries which were soon installed into the UPS and everything was back to normal.

Our records show that the batteries lasted 5 years, and according to the battery specifications it's quoted as between 3 to 4 years, so we have not done badly out of them.

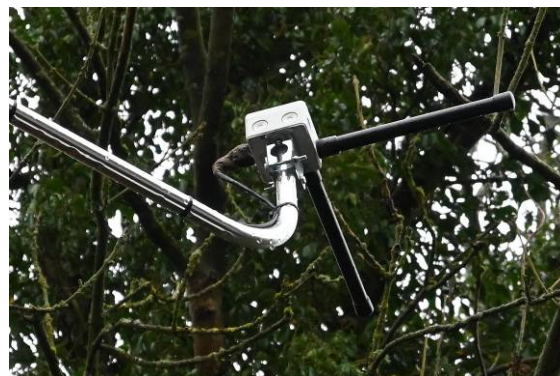
Unfortunately problems struck the project in August when one of the H-Plane Antenna amplifiers was showing a very low noise floor and its performance has dropped off quite dramatically. Despite a few adjustments it was clear that we had a problem which could ether be an Amplifier had died or an Antenna fault or something in between. So a site visit was needed to investigate.

After a few cursory checks of the installation and the exterior hardware, just to make sure some pesky rodents had not decided to have a meal of our UTP cable, we disconnected the Antennas to find that all the noise floors fell to around the same values, this was good news!

The decision was then made to lower the twin H-Plane antennas (see pic). Each of the two antenna rods come together in a waterproof box inside which is a small PCB which contains the antenna terminations to the first active RF Amplifiers stage.

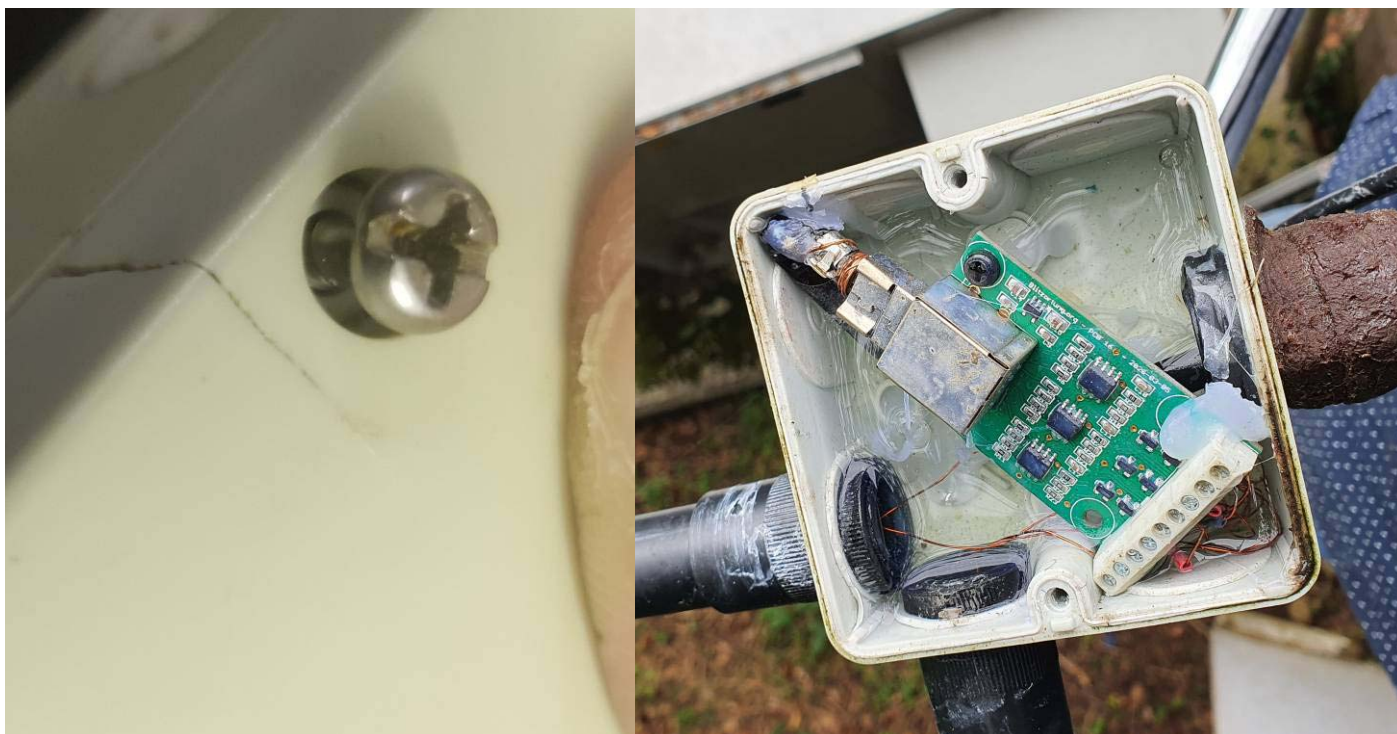
Standing precariously on the top of the ladder, so as to gain access to aerial box and the screws holding the lid on, I started to unscrew the 4 screws when I noticed a very small crack on the side of the box cover, which opened up when the adjacent screw was removed. Emmm, not a good sign I thought.

With the cover now fully removed I quickly saw the problem. The antenna box was full to the brim with water and the surface mount PCB was almost fully immersed apart from one small part. This part contained the Amplifier IC and was still working, the rest was under water and it was clear this was the problem. The small desiccator that was added to help keep any damp out was also under water; clearly it had not done its job!

To find the box full of water was annoying as it was supposed to be IP66 rated, but due to the crack found in the lid this rating was immaterial. So the H-Plane antennas were removed from site for repair. The unit was left running on the separate H-Plane Antenna which it turned out worked reassuringly well.

The good news was that although the small PCB took a bit of damage from being immersed in the water and along with the DC supply to the submerged board caused one of the small tracks on the PCB to get eroded away. Fortunately Mat – G7FBD was able to make a full and proper repair to the PCB.

Mat also contacted the company that supplied us the water proof box, who were kind enough to replace it free of charge. So the new Mk2 Antenna box was constructed, which now includes a drain hole, just in case.

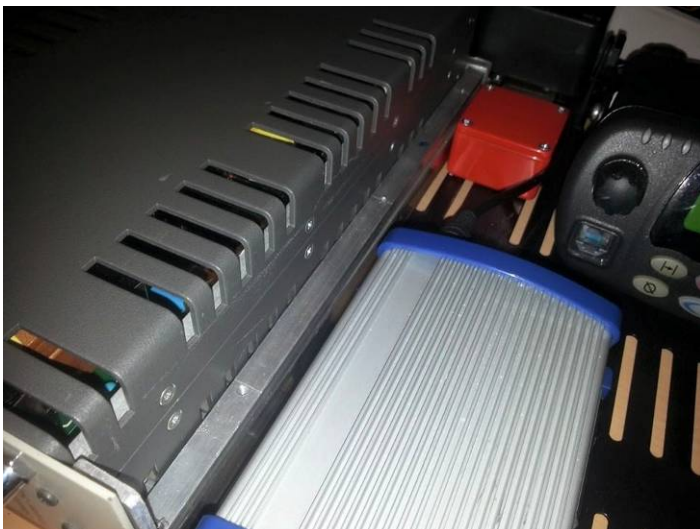
The Isolation transformers are in a small 2" square dicast box (red in the picture to the left).

Inside I had added test points as at the time of build I thought they may come in useful at some point. I was able to attach my Oscilloscope to these test points and discovered audio was not getting to the transformers from the modem. The cable and plug (Mini 6 pin din-plug) were all tied down and plugged in firmly.

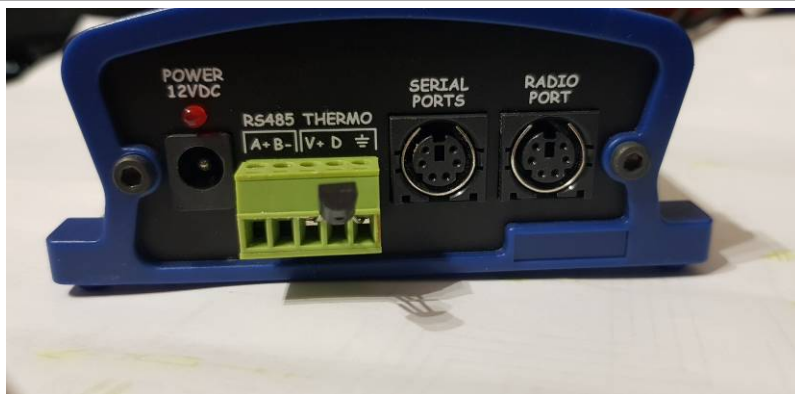
I gave the plug an un-necessary push to make sure it was connected to the modem. I removed the plug and scoped the connector; this confirmed audio was being generated by the modem. So the fault had to be either the plug or the cable. Both looked visually in good condition.

Cutting back the heat-shrink the joint looked sound. So it's not clear the cause of this fault. But fault all the same.

Firing up the heated metal glue gun (Soldering Iron), I cut back the broken wire and was able to re-terminate it back onto the plug (Tip for the young players out there, always leave enough spare to enable you to re-terminate a wire if needed).

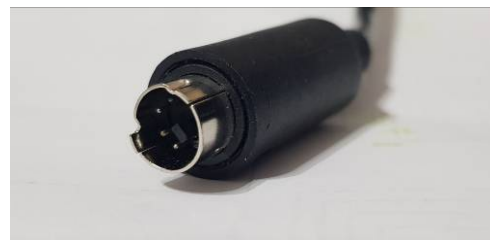
Next, I took the 6 pin Mini Din plug apart. I personally think they are the worse connector ever. Everything looked in order.

Okay when I assemble plugs and sockets, I try to either heat-shrink or Hellermen sleeve the wires once soldered to the connection. In this case I used heat-shrink over the wires. When I gently pulled back on the wires sure enough one wire pulled out and as you guess it was the audio line from the modem out towards the transformers. Interestingly the wire that pulled out only had a single strand protruding out of the insulation.
