THE BRISTOL 70cms REPEATER GROUP

GB3BS NEWSLETTER 2012

Technical Report

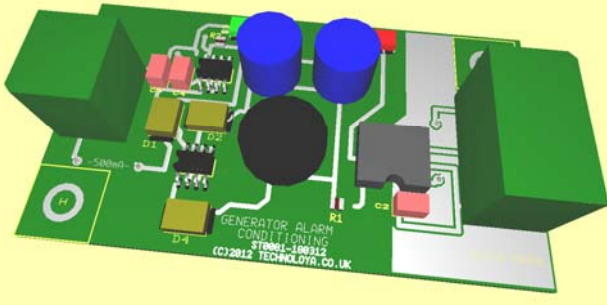
Fortunately the Arcom repeater controller has alarm inputs and control line outputs available as standard. However, all these inputs and outputs are not "buffered", in that they are connected directly to the main microprocessor. In order to protect the CPU, all inputs and outputs pass through our Logic Interface unit, this provides buffering, thus protecting the CPU from any undue voltages that may harm it.

Computer representation of the opto-interface board ©

Mat came up with a small and simple opto-isolated trigger circuit that would ignore all these bounces and provide a clean and reliable switch that would operate the alarm. This was installed and tested; all appeared to be ok but there were still odd & unexplained double voice announcements being heard on the repeater.

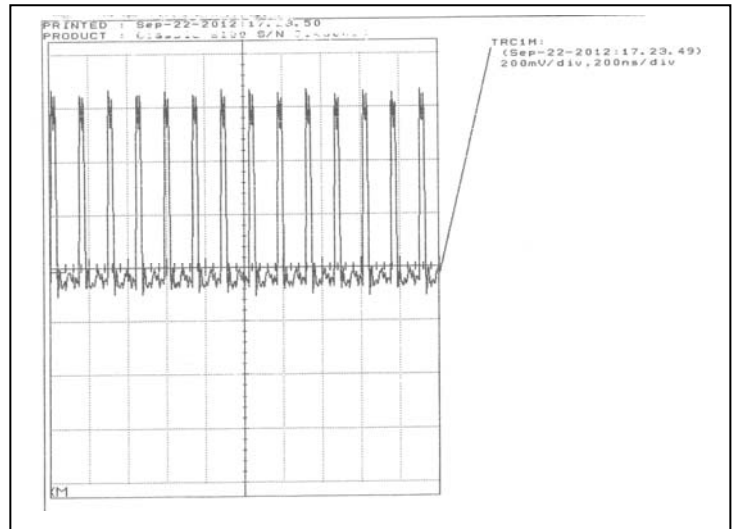
Following several trips to site and the need to take the repeater out of service while we investigated the cause of these false triggers we had a breakthrough. The IC which we were using to buffer both input and output lines of the CPU was found to be “self oscillating”, in fact this oscillation was measured at almost 5MHz.

This digital 5MHz noise was even getting onto the power supply rails that fed the logic interface board. Looking at it with a digital scope showed up the full extent of the problem and how widespread the digital noise was. The problem was not with the circuit design itself but that there was an oversight by us in that the IC used for buffering had a mixture of unused input and output gates!

Apparently it is good practice to tie, or park, these unused gates either to a logic high or low state. It was these gates which were oscillating uncontrollably and causing the generator alarm to false trigger.

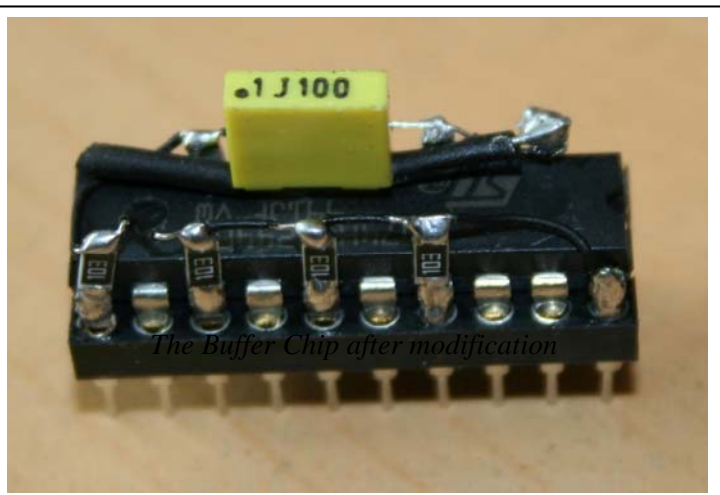
Mat carried out a modification to the buffer IC by fitting some resistors to the unused gates, pulling them all to Vcc. This has successfully stopped the oscillations completely in its tracks.

So far this appears to of finally fixed the problem, fingers crossed! We will ensure that this modification is implemented on our new Mk2 Interface board which is currently still in its design stage.

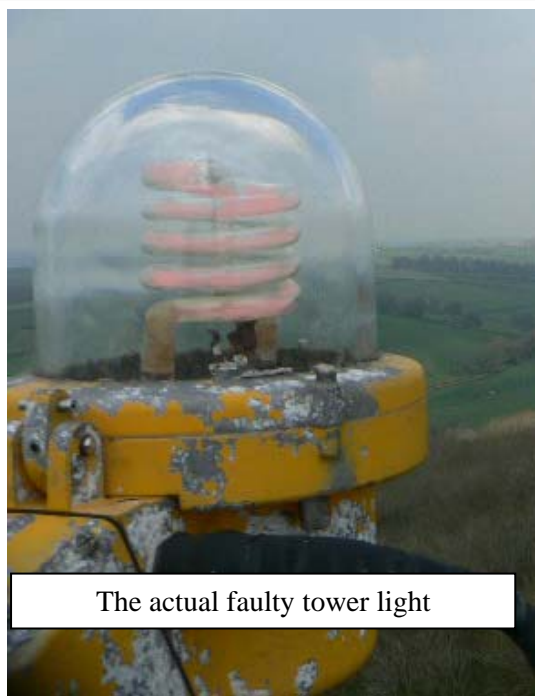
The actual faulty tower light

The problem turned out to be with the tower warning light, which is controlled by a dawn to dusk light sensor. Every time it got dark enough for the tower light to come on then the main circuit breaker would trip out causing the generator to start up.

Following a Saturday afternoons site visit and some standard mains insulation testing we found that there is a breakdown of the insulation between the 240V live and earth of the light assembly at the top of the tower.

This 240V circuit has now been isolated at the fuse board and was reported to the site owner, who in turn have notified Bristol Airport and the CAA. As you can appreciate we are not responsible for the tower light so repairs are out of our control.

We are aware that our findings as to the fault were confirmed by the site owner and they are currently arranging for this to be fixed. There is no information as to lead times to repair, or if the tower owners will actually instigate a repair. We will keep you posted.

Speaking to the contractors they confirmed the tower light was beyond repair and was to be replaced once a climb certificated electrician was available. They also explained what exactly the inspection involved. As you can see from the picture all structural aspects were inspected including the base of the legs. The picture shows the shuttering enclosing the fresh concrete and anti-corrosion mix after removal to expose the base of the legs. The tower is healthy and good for a few years yet!

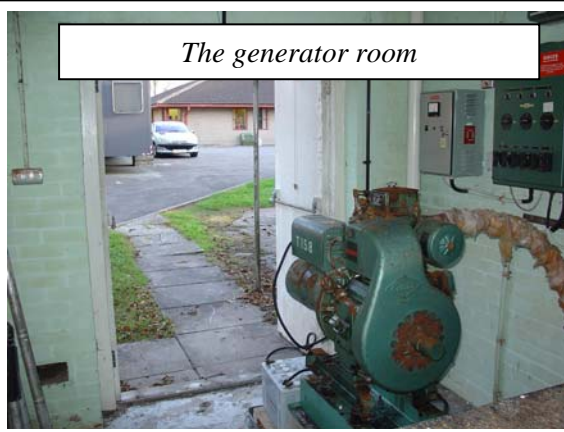
The generator room

However, we have got the generator room into a reasonable condition but does still require the walls and ceiling to be cleaned, primed and then painted along with the floor given a coat or two of sealing resin.

We anticipate that this work will start when the weather gets a bit warmer in the spring of 2013. During one recent site visit we did a bit of tree pruning, clearing of tree debris from the flat roof and keeping the rain water soak a ways clear.
